Manholes: Status Documentation Wastewater Conveyance System The Green Association

February 4, 2015, rev.

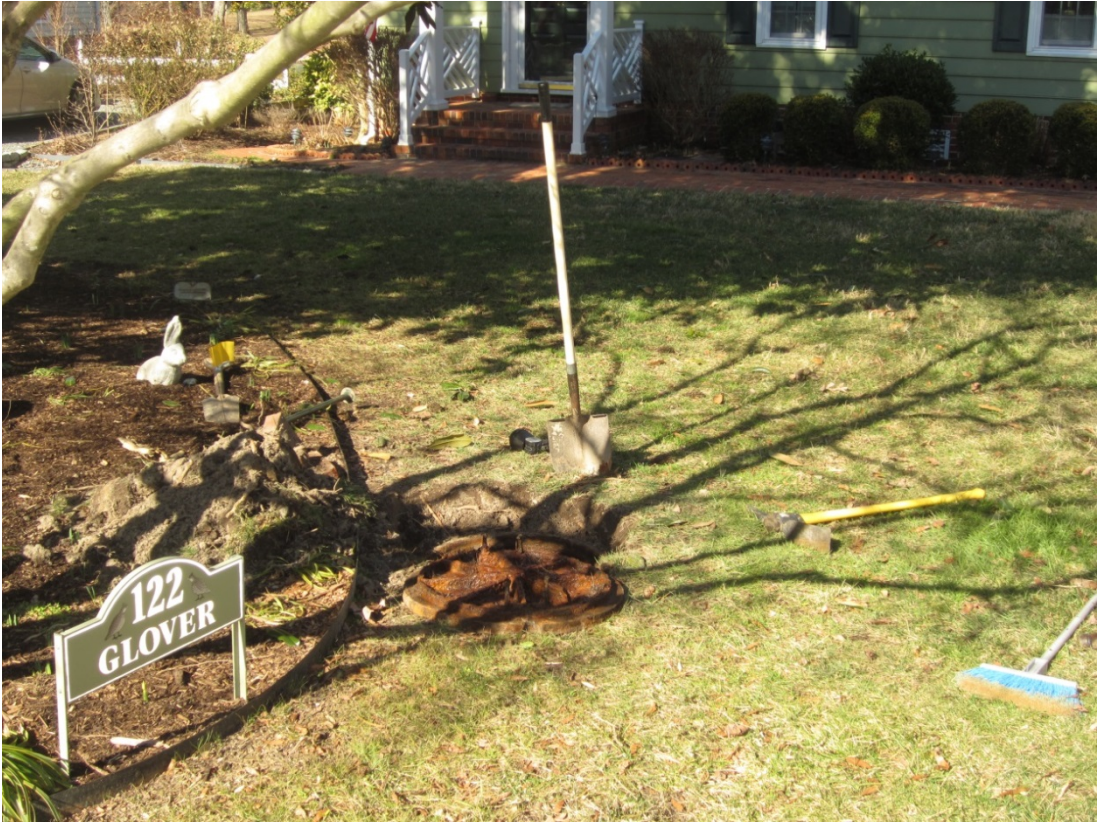
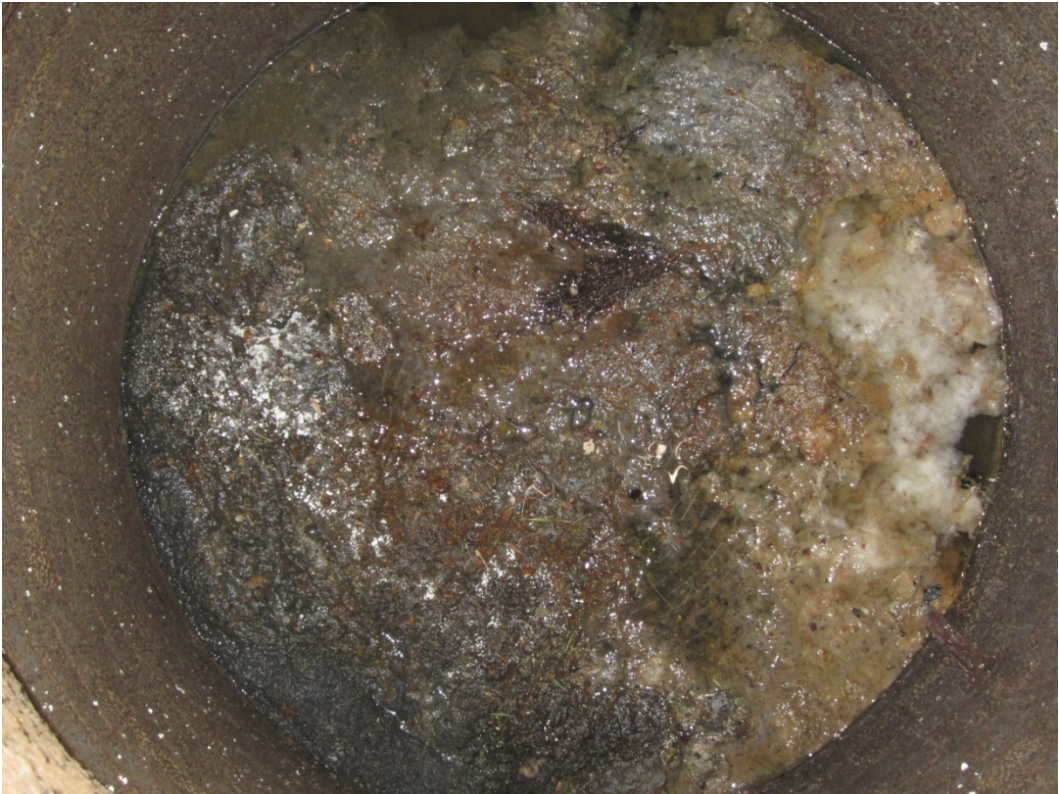
Manhole #1

Number	Location	Depth (inches)	Distance to Next (6" Cast Iron)	Concerns
1	Front of Unit 8A, 41' from front of bldg	75		Apparent blockage at 35' dnstream, no inlet or outlet pipes visible-see pic—obstruction cleared by high pressure water jetting *Increase elevation by 6" to raise to surface
	Serves Units 7A/7B/8A		84'	
2	Front of Unit 8B, 50' from front of bldg	90		*Increase elevation by 6" to raise above bed
	Serves Unit 8B & manholes #1 & #3		188'	
3	Front of Unit 4B, 41' from front of bldg	74		
	Serves Units 4A/4B/5A/5B/6A/6B		96'	
4	Intersection of Muirfield Ct. & The Green streets	152		
	Serves manhole #2 & #5, then outlets to pump house		110'	
5	Front of Unit 11B, 85' from front of bldg	49		
	Serves building Units 9-12		146'	
6	Front of Unit 2A, 36' from front of porch	84		
	Serves building Units 1 & 2		133'

- Determine condition of cider block pump sump pit
- Determine volume (gal) of pump cycle
- Estimate remaining life of all components
- Revise reserve account to reflect current condition
- Install concrete risers to raise three manhole lids [#1, 2, & 7]
- Install automatic dialer on alarm system
- Service Phase Sequence & Loss Monitor, Model #SLA-230-ASA (see pic)

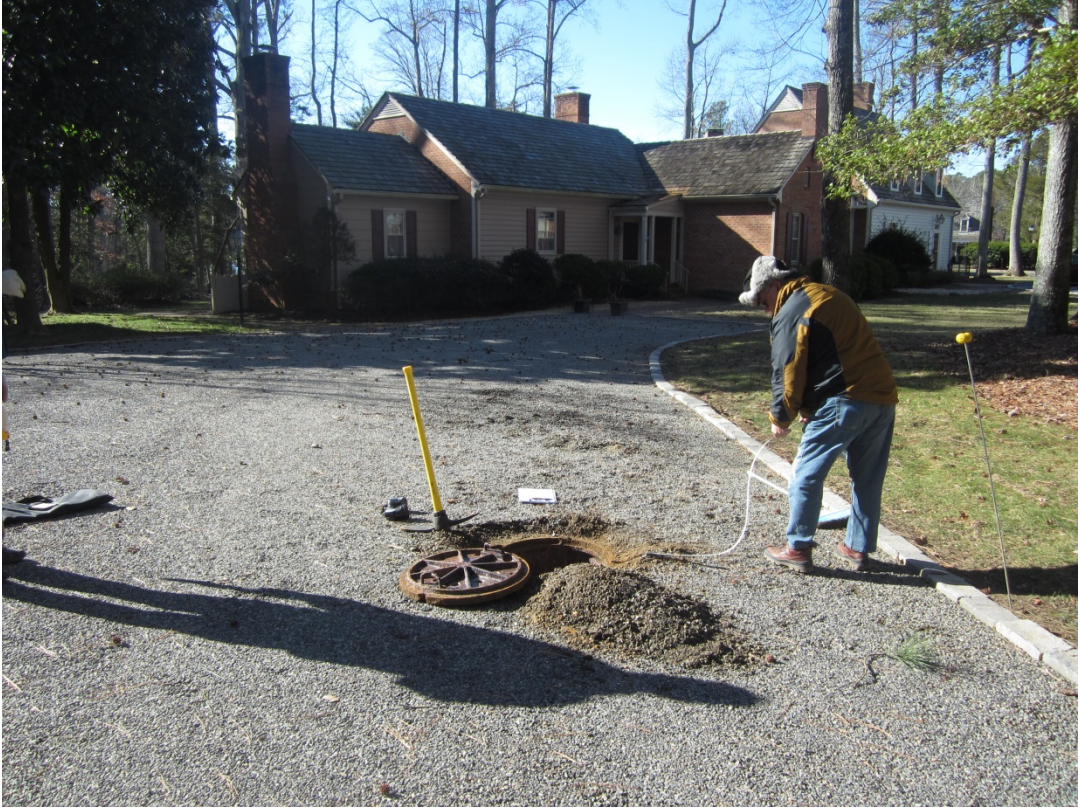
Manhole #7

7	Front of Unit 3A, 67' from front of building	115		*Increase elevation by 2" to same level as stone in drive
	Serves Units 3A/3B and manhole #6, then outlets to pump station		85'	
TOTAL			842'	Cast iron pipe
